**HYDROLOGY STUDY OF  
SALT SLOUGH, MERCED COUNTY**

**California Regional Water Quality Control Board  
Central Valley Region  
3443 Routier Road  
Sacramento, California 95827-3098**

**February 1989**

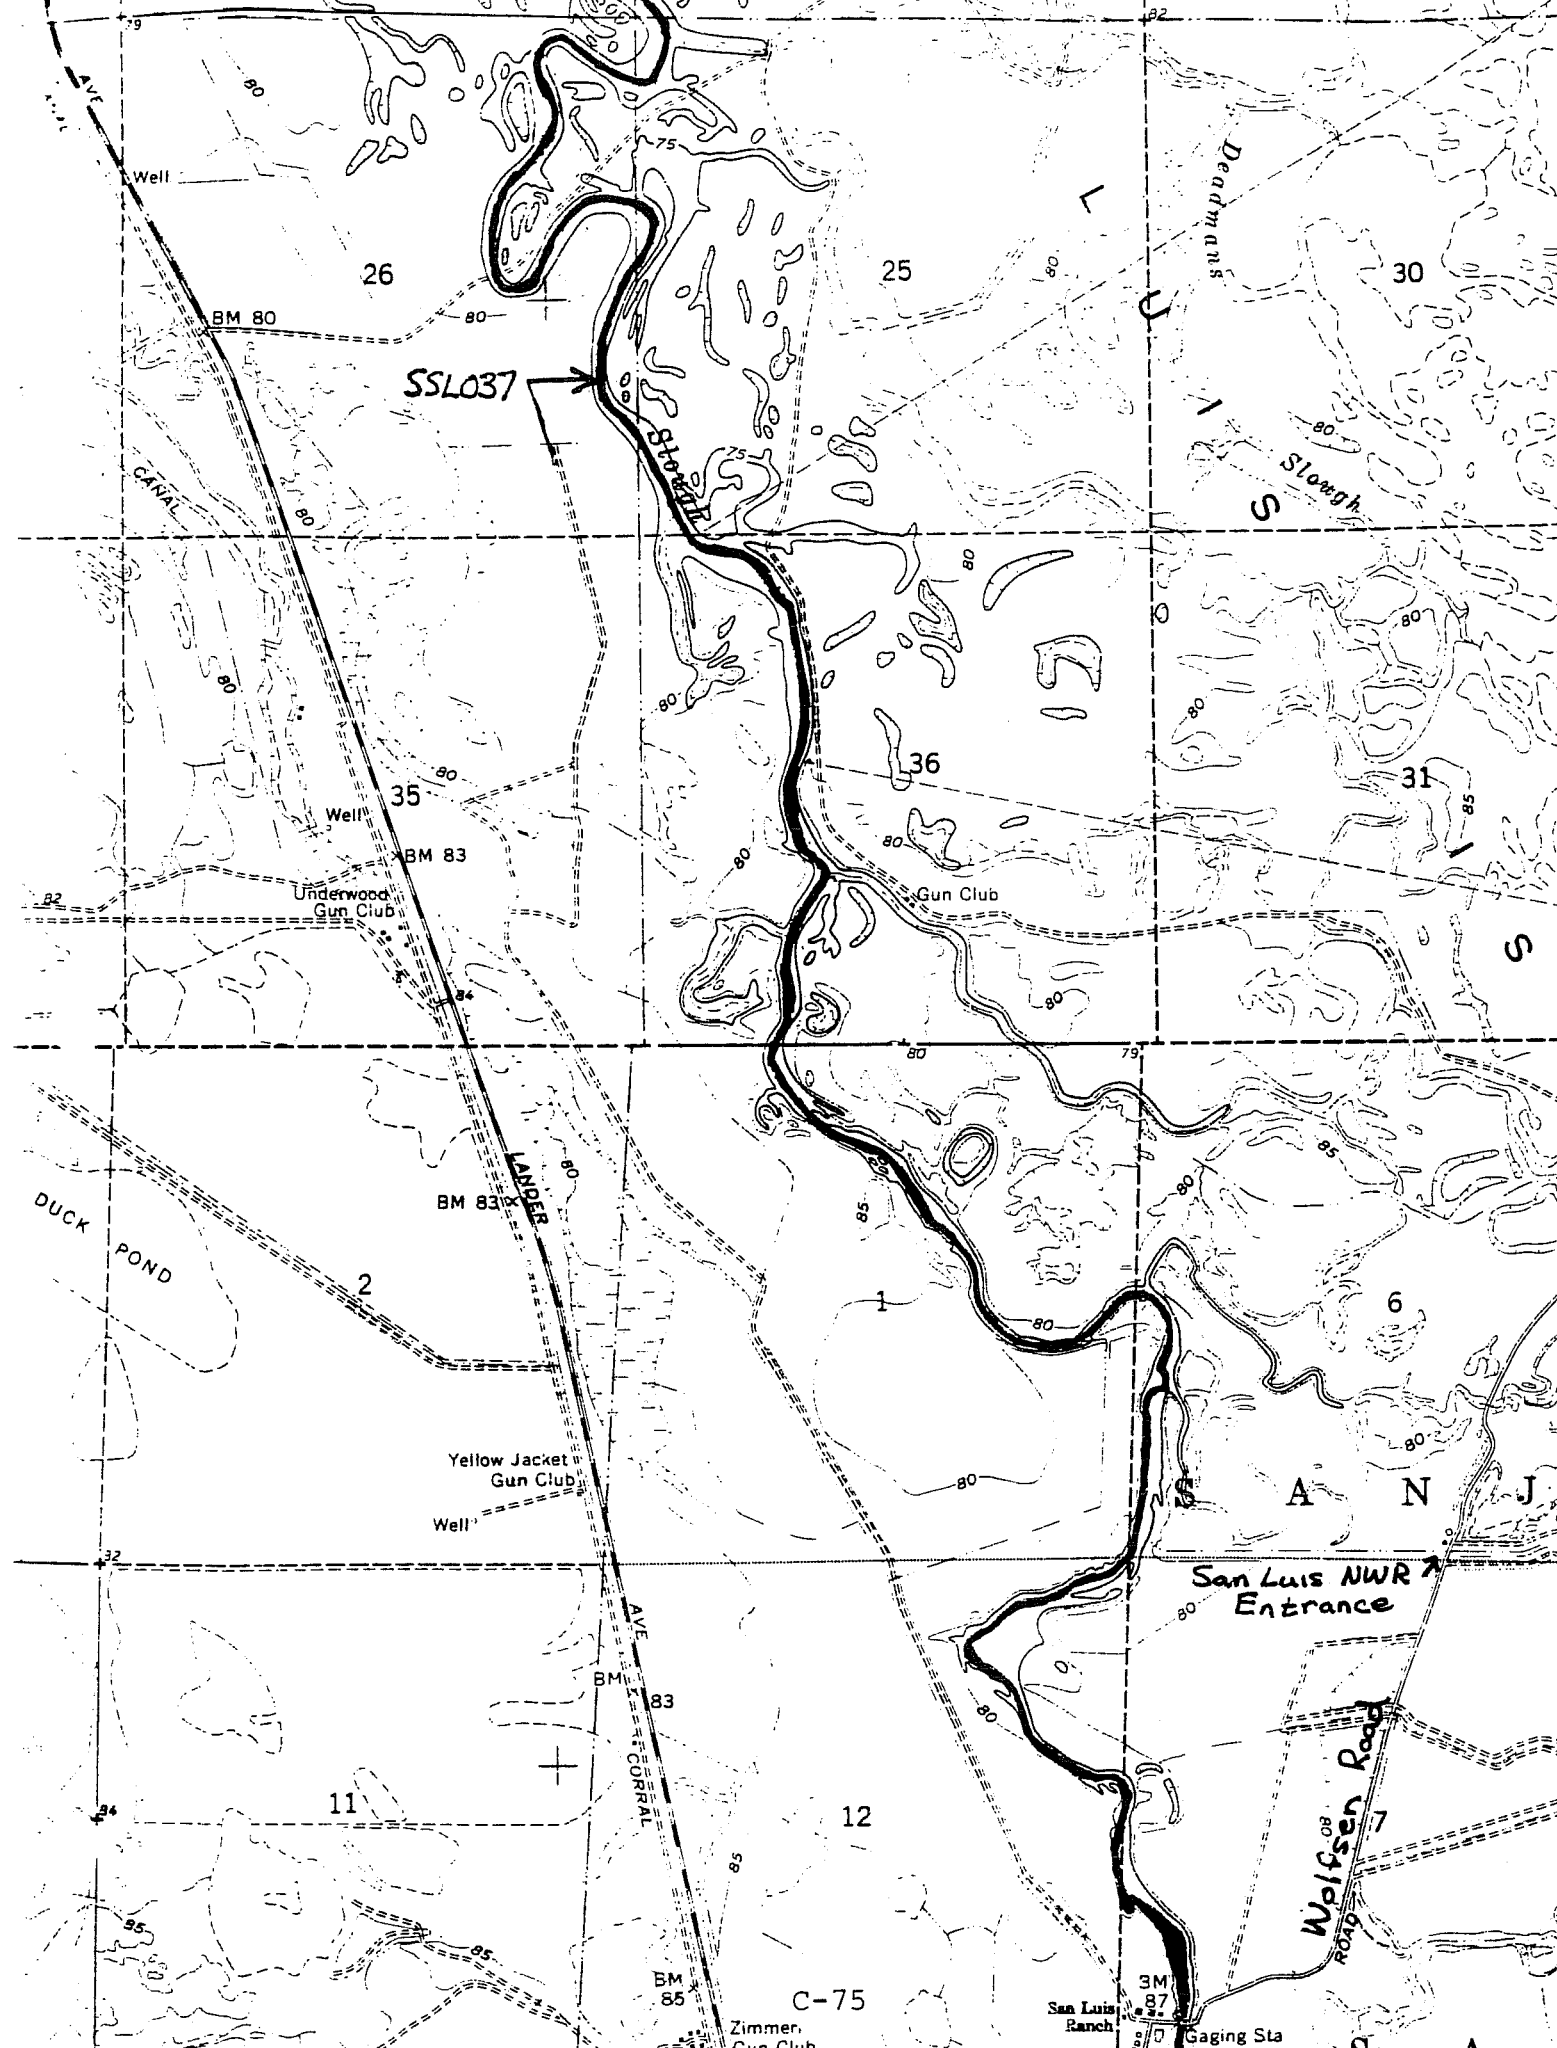
SITE ID #SSL037

**Site description, location, and access:** From Los Banos take Mercy Springs Road north for approximately 6.5 miles to Wolfsen Road. Proceed northeast on Wolfsen Road for approximately 2.1 miles to the entrance of the San Luis National Wildlife Refuge. At this point, you will have just passed over a large canal. Follow this canal west, along the north side, to Salt Slough. From here, proceed north for 3.25 miles to where a channel enters the Slough from the west bank. This is the discharge site.

**Type and source of water being discharged (description):** This drain drains a fairly large area of pastureland to the west of Salt Slough and south of its discharge to Salt Slough.

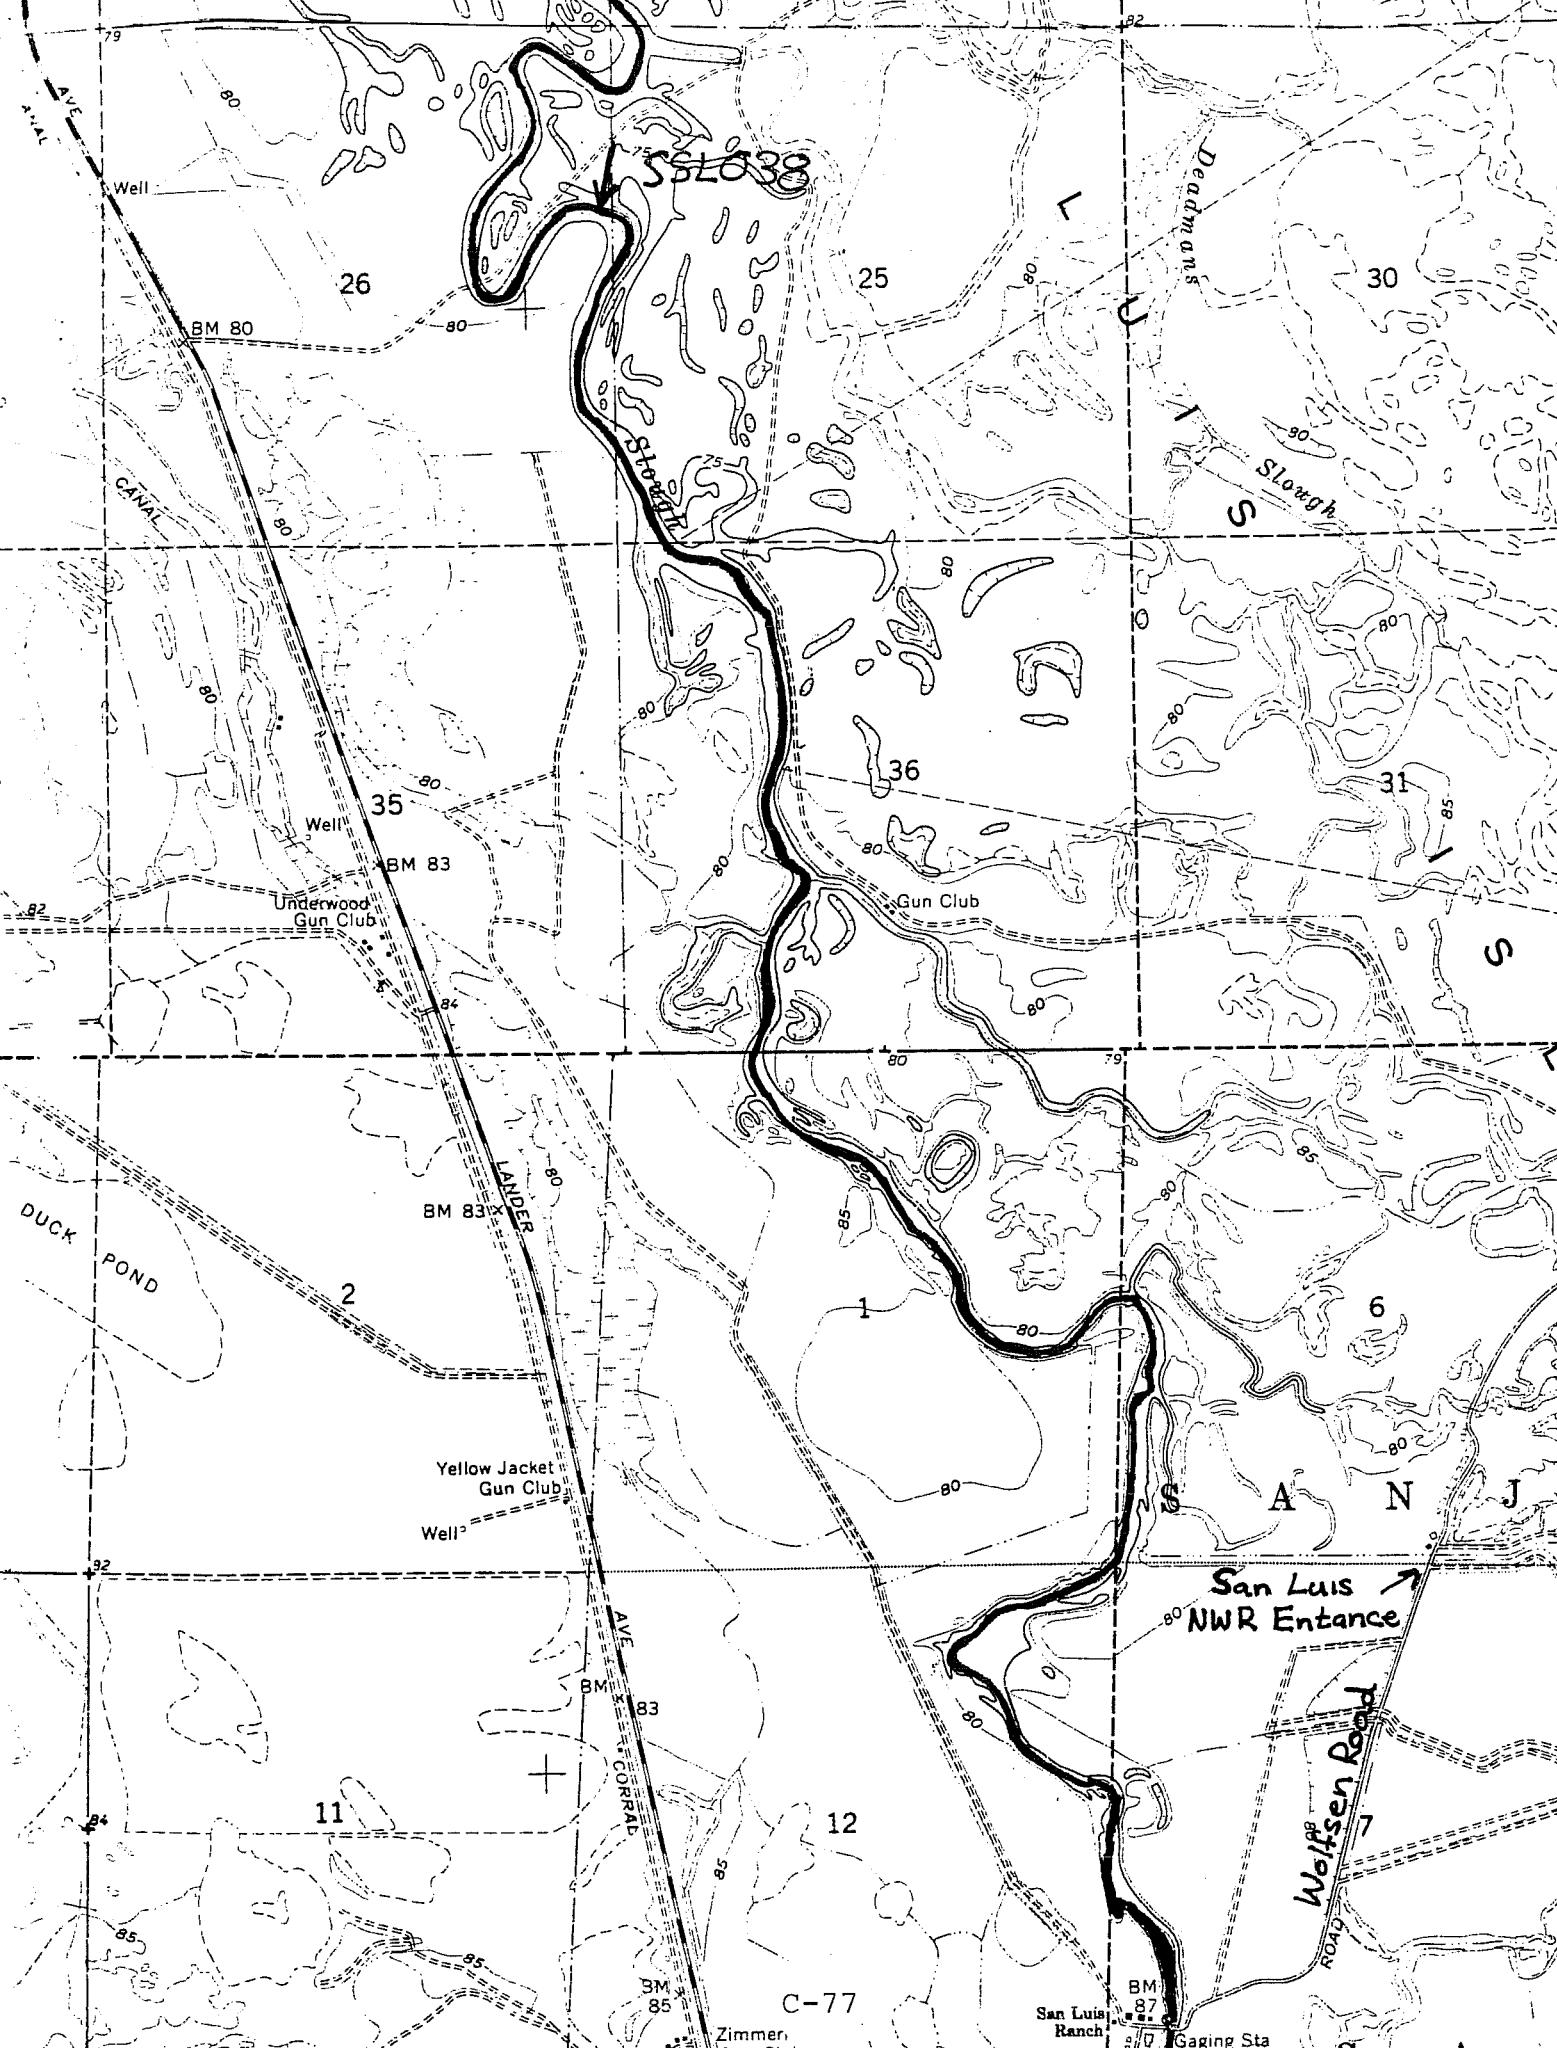
**SITE ID** #SSL038

**Site description, location, and access:** From Los Banos take Mercy Springs Road north for approximately 6.5 miles to Wolfson Road. Proceed northeast on Wolfson Road for approximately 2.1 miles to the entrance of the San Luis National Wildlife Refuge. At this point, you will have just passed over a large canal. Follow this canal west, along the north side, to Salt Slough. From here, proceed north for 3.55 miles to where a channel undercrosses the road, entering the Slough from the north. This is the discharge site.

**Type and source of water being discharged (description):** This drain drains water from a small portion of the San Luis National Wildlife Refuge just to the east of Salt Slough.

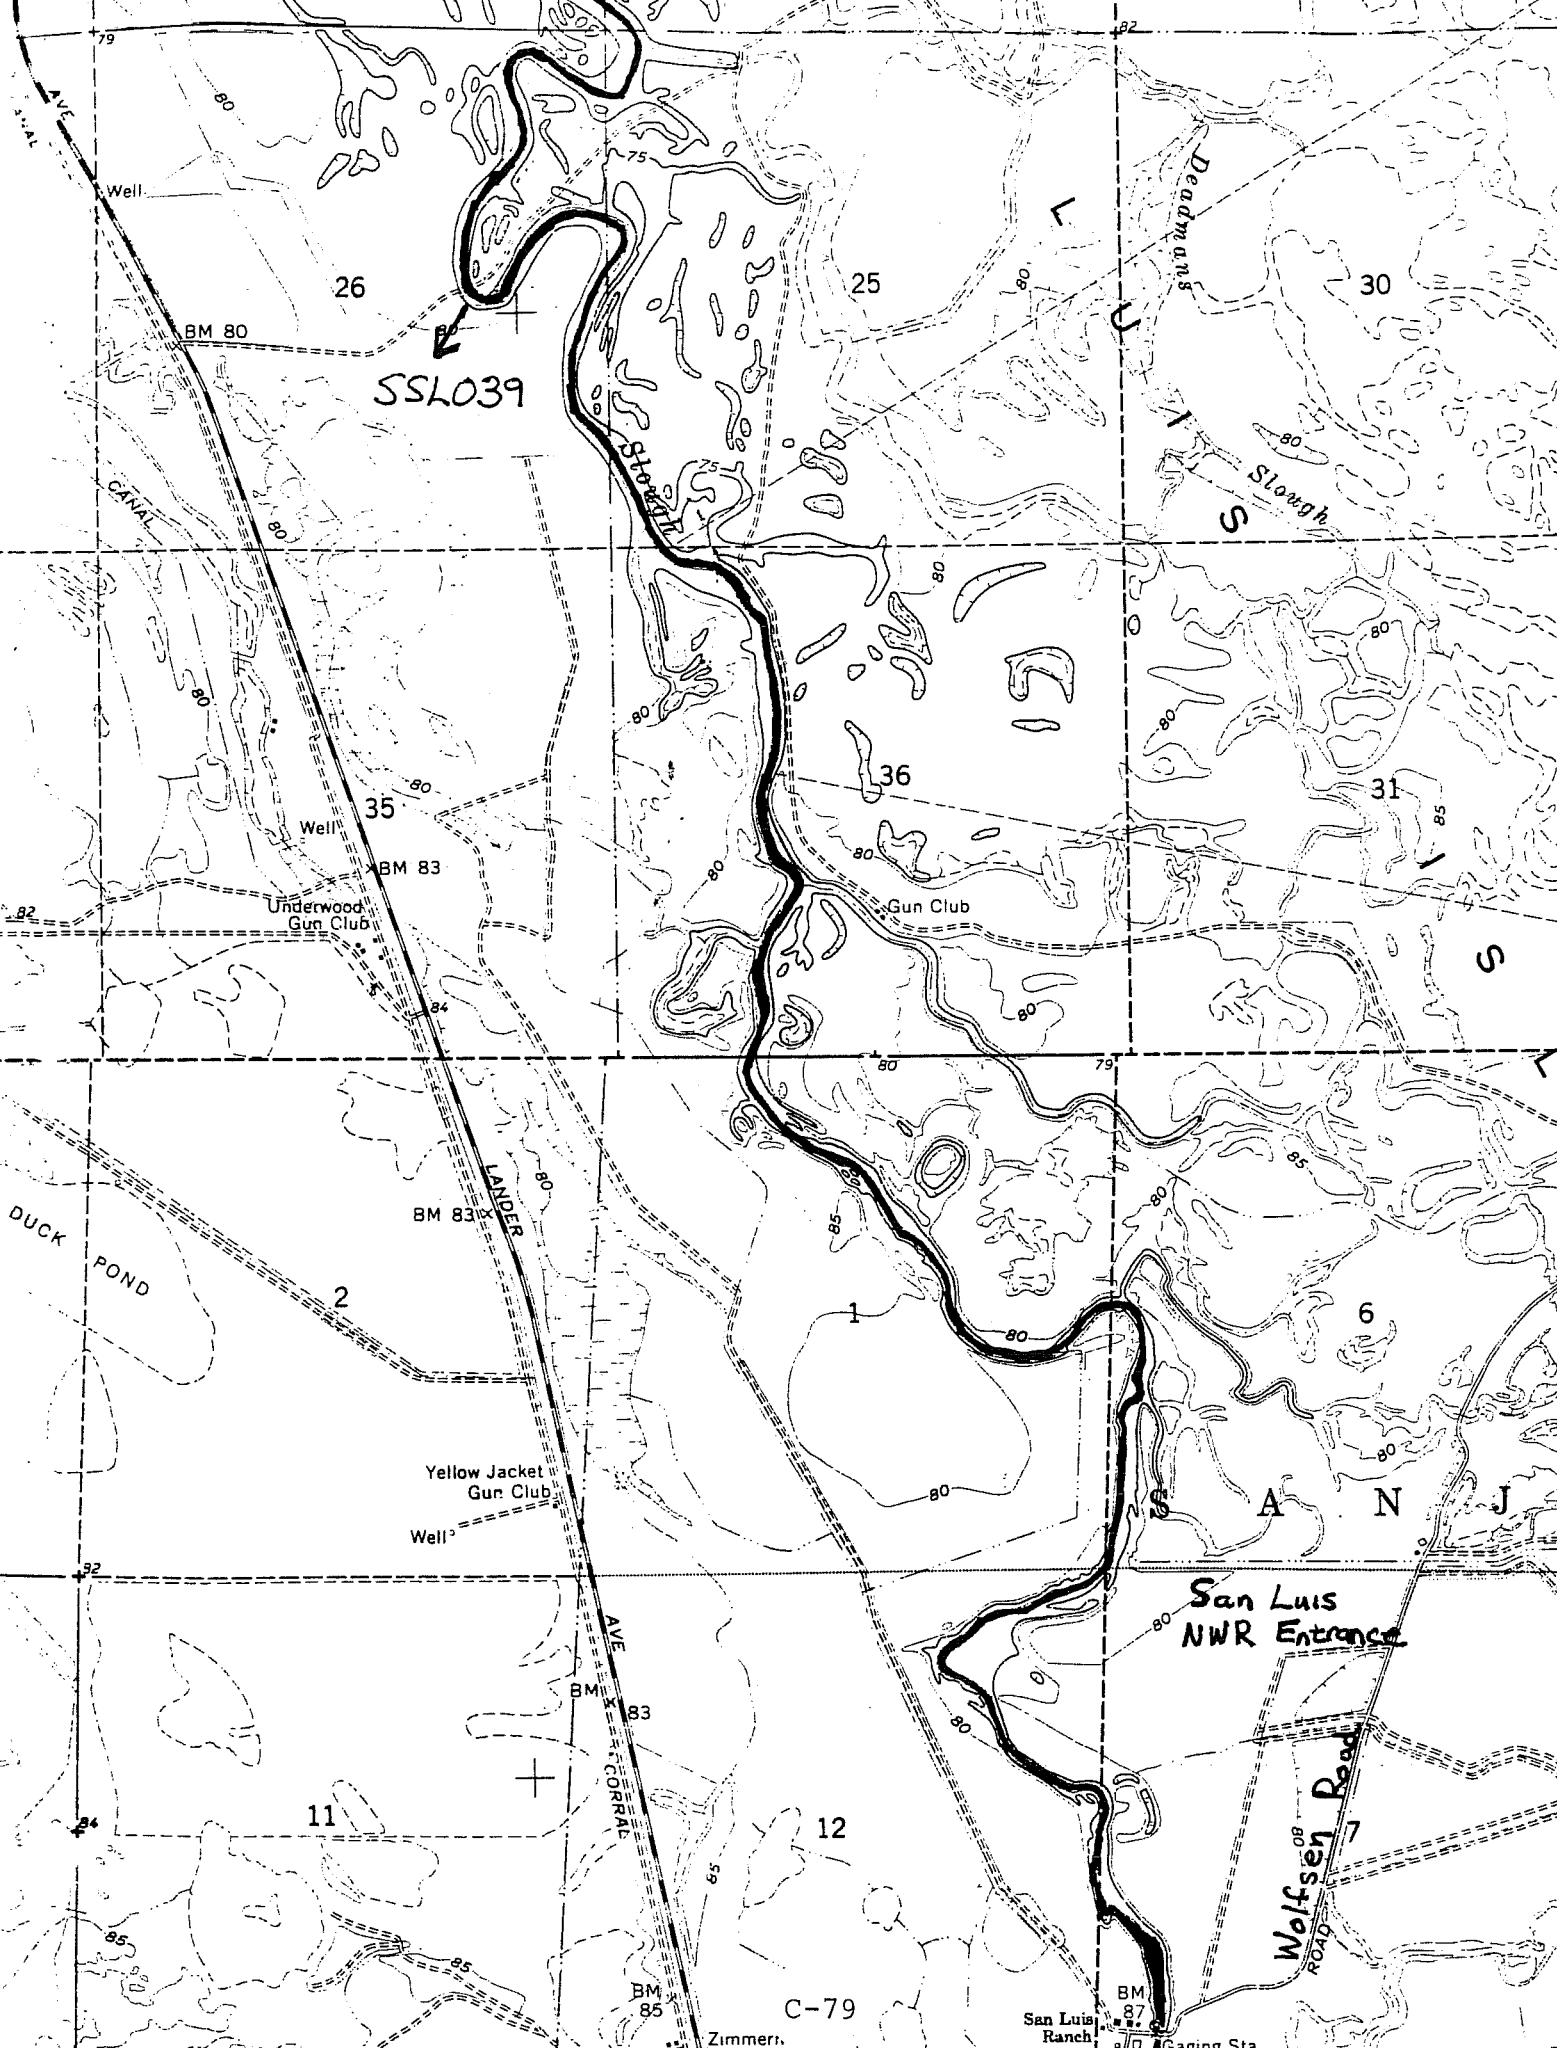
**SITE ID #SSL039**

**Site description, location, and access:** From Los Banos take Mercy Springs Road north for approximately 6.5 miles to Wolfesen Road. Proceed northeast on Wolfesen Road for approximately 2.1 miles to the entrance of the San Luis National Wildlife Refuge. At this point, you will have just passed over a large canal. Follow this canal west, along the north side, to Salt Slough. From here, proceed north for 3.85 miles to where a bridge crosses Salt Slough. Just south of this bridge, on the west bank, a pump lifts water from the Slough. This is the diversion site.

**Type of diversion and use of the water:** At this site, water is lifted from the Slough by pump and used to irrigate pastureland west of Salt Slough. The quantity of water diverted at this point is 3.0 cfs.

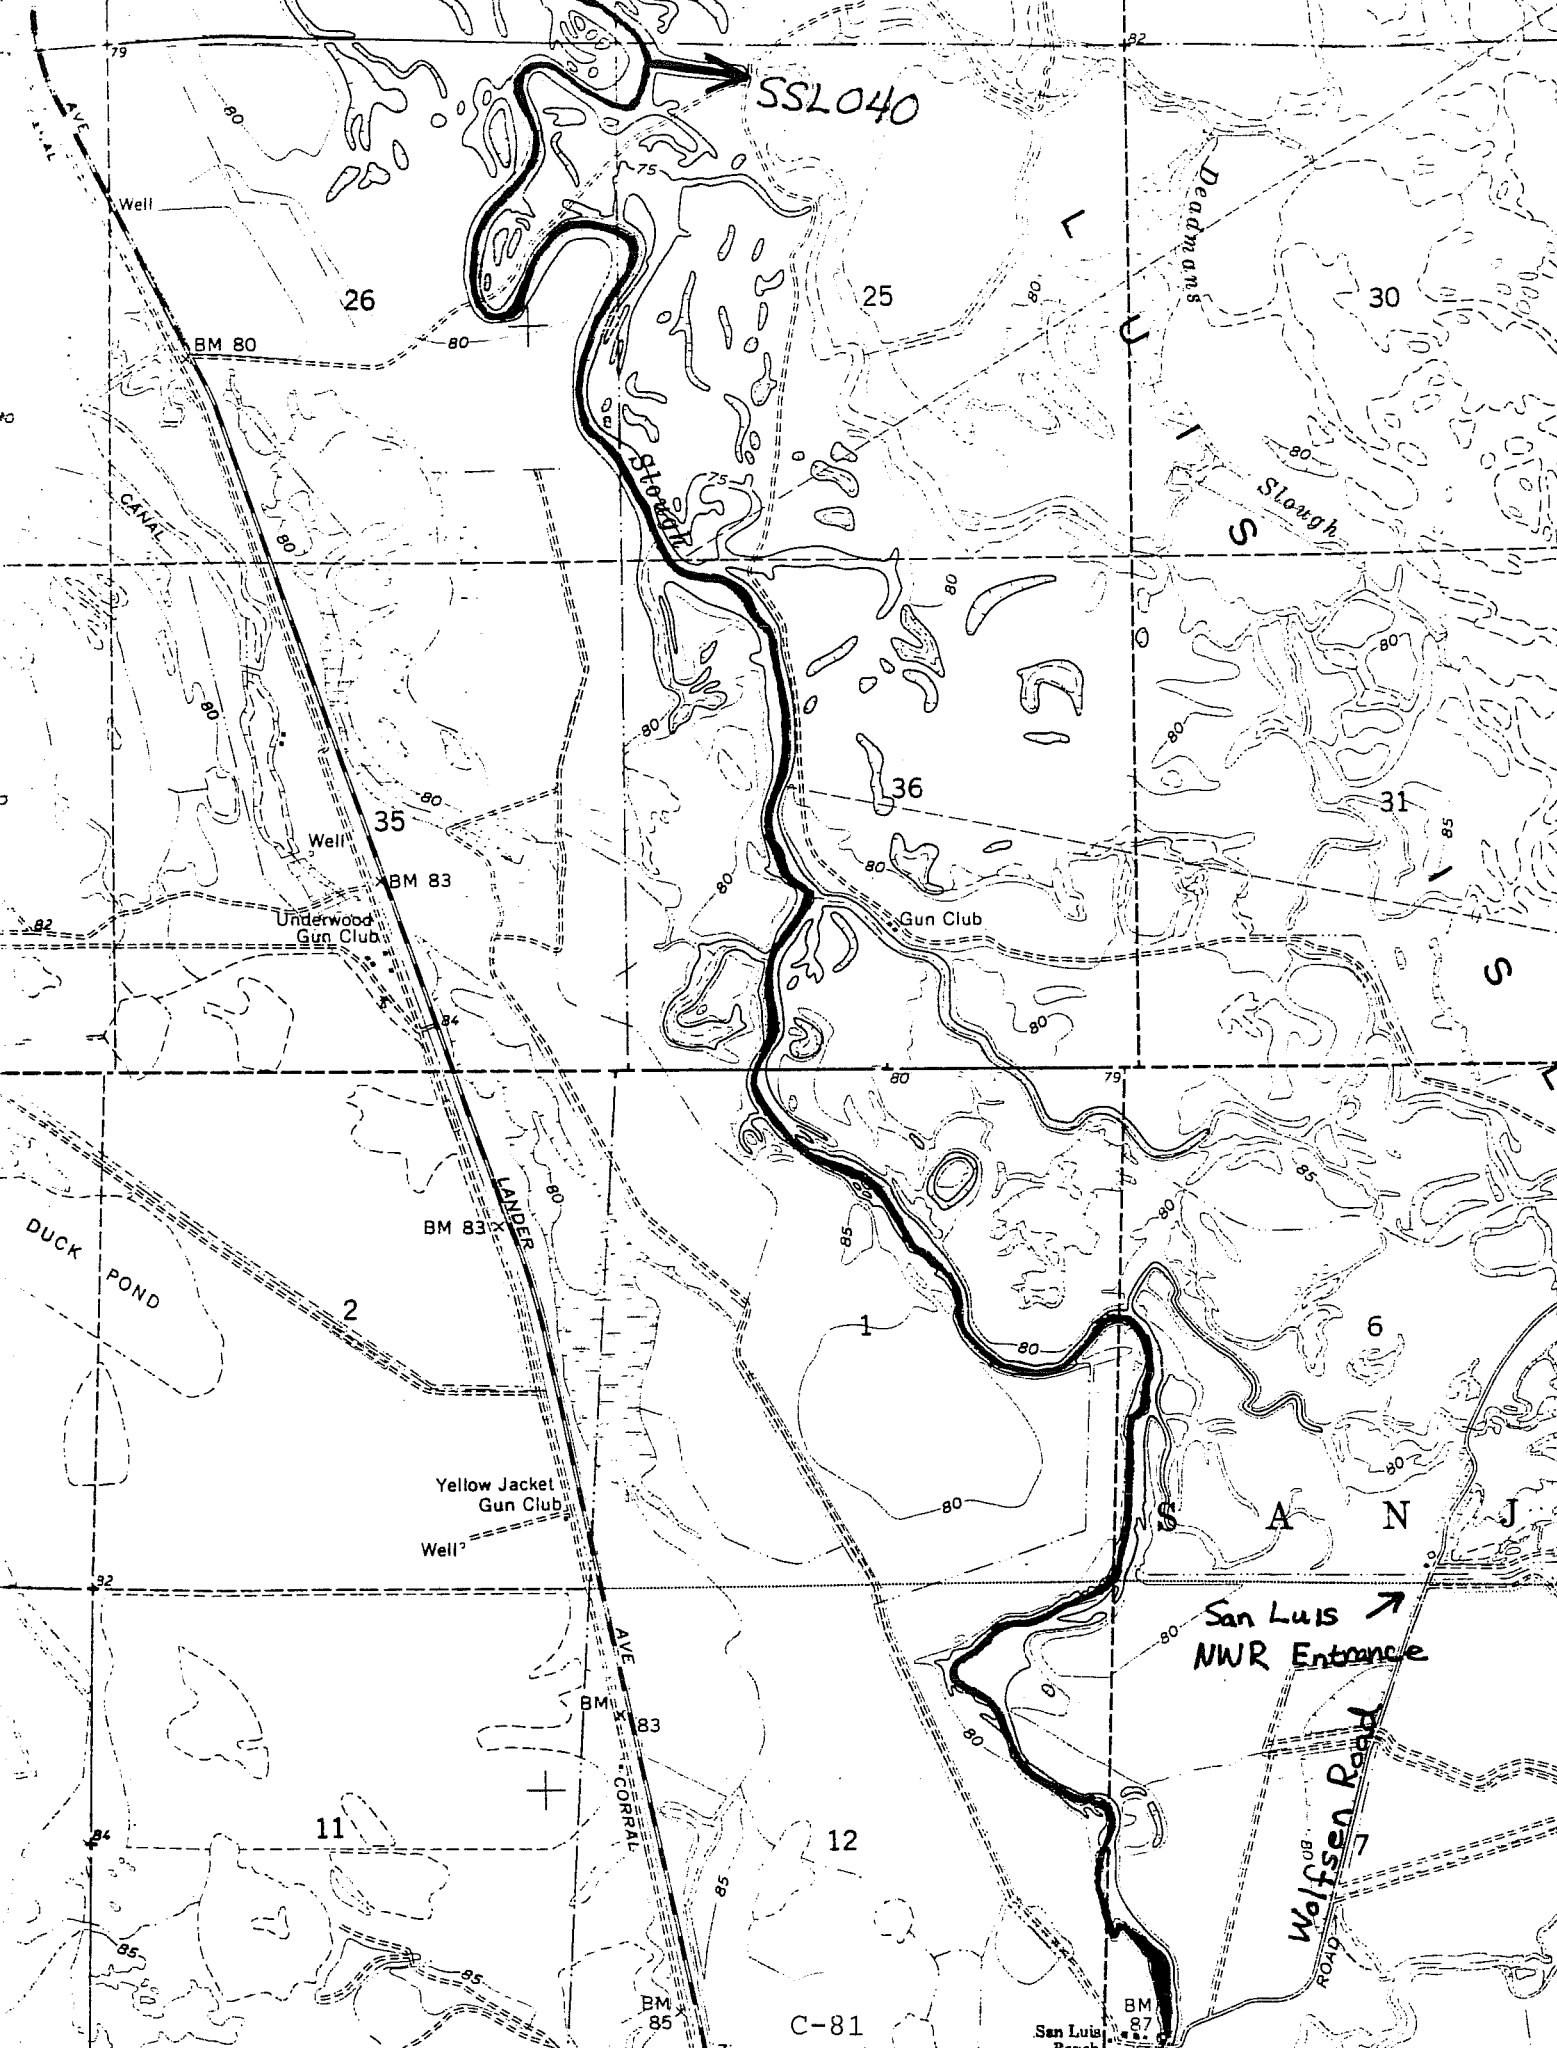
**SITE ID #SSL040**

**Site description, location, and access:** From Los Banos take Mercy Springs Road north for approximately 6.5 miles to Wolfsen Road. Proceed northeast on Wolfsen Road for approximately 2.1 miles to the entrance of the San Luis National Wildlife Refuge. At this point, you will have just passed over a large canal. Follow this canal west, along the north side, to Salt Slough. From here, proceed north for 3.65 miles to where the levee road intersects with another dirt road. Head northeast on this road for 0.5 miles to a large pumping station. This is the diversion site.
